LITECAST INSTALLATION GUIDELINES

Beam and Concrete Block

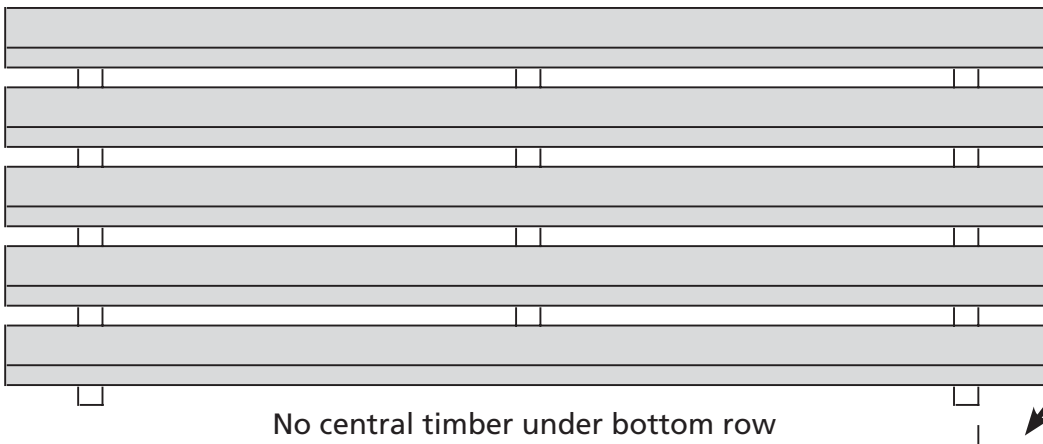
CORRECT

Timber bearers should be placed on firm level ground. There must be no central timber on the bottom row. Incorrect stacking will result in excessive camber and possibly broken beams.

Beams of similar length

Timber supports in line

Timbers positioned no more than 200mm (8") from the end

No central timber under bottom row

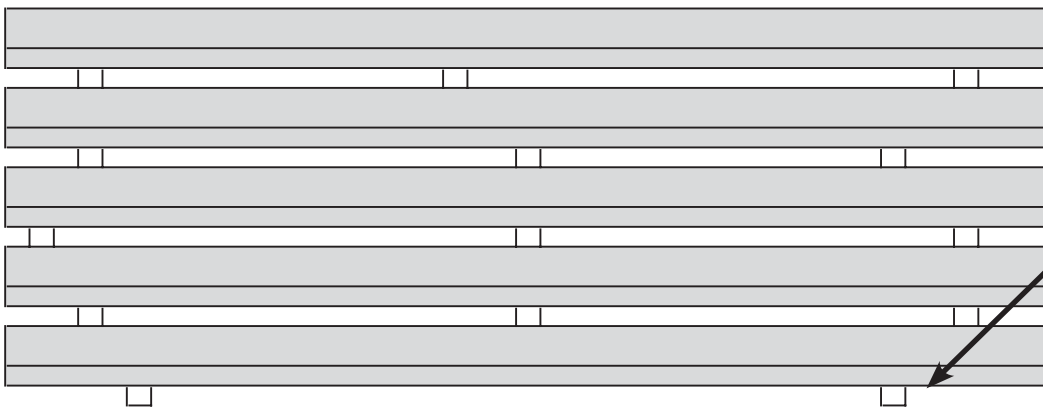
INCORRECT

Timber supports not in line

These beams will crack at this point

No central timber under bottom row

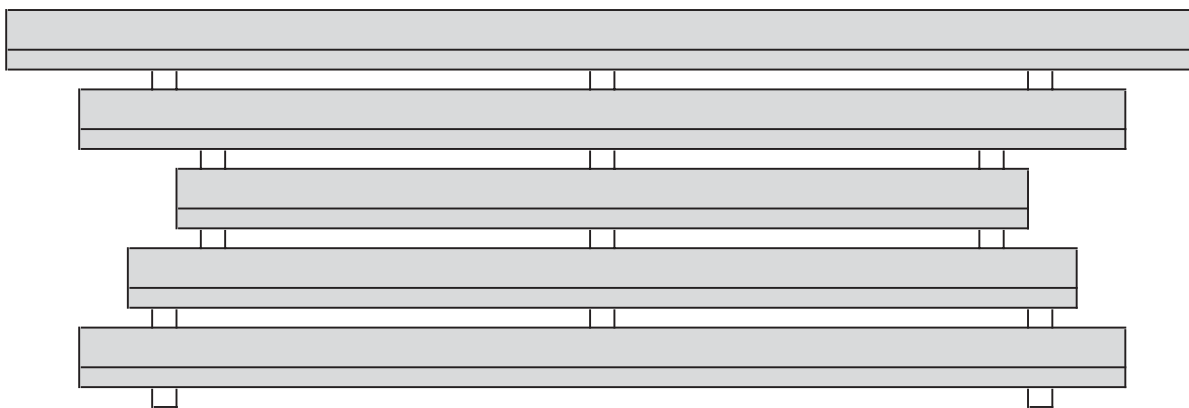
INCORRECT

Longer beams overhanging beams below

Danger to pedestrians

Abnormal loadings on beams below

No central timber under bottom row
